2016 Monitoring Summary

Little Butler Creek at Lauderdale County Road 61 (34.98226/-87.61645)

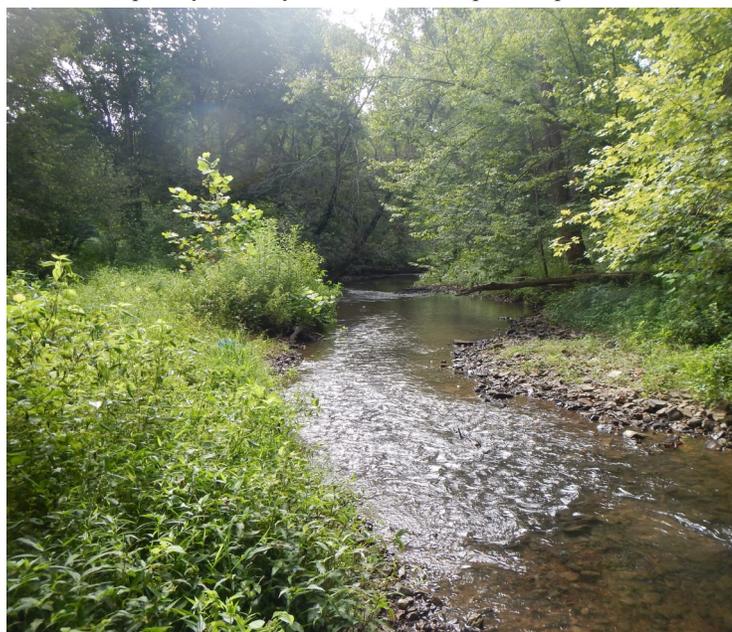
Figure 1. Little Butler Creek at LBTL-1 on May 3, 2016.

General observations (Figure 1, Table 2) and habitat surveys (Table 3) were completed during the Index of Biotic Integrity (IBI) fish assessment. In comparison with reference reaches in the same ecoregion, they give an indication of the physical condition of the site and the quality and availability of habitat. Like other streams in ecoregion 71F, Little Butler Creek at LBTL-1 is a medium-high gradient stream characterized predominantly by cobble and gravel substrates. Overall habitat quality and availability was rated as *Optimal/sub-optimal* for supporting the fish community and the overall ecology of the stream.
